Seismic Vulnerabilities - One- and Two-Family Wood-Frame Dwellings - Voluntary Seismic Rehabilitation

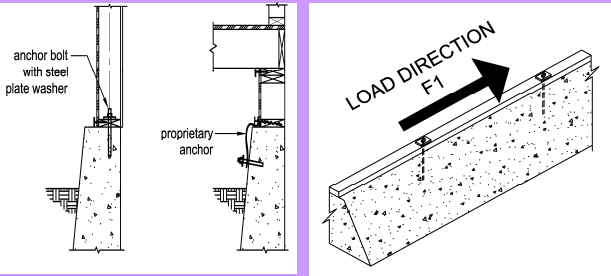
Wood framing can slide relative to foundation	For dwellings with wood-frame floors with crawlspace, look from inside crawlspace at dwelling perimeter	-Dwellings built prior to approximately 1950 are not likely to have anchorage (date may vary) -Dwellings with cripple wall bracing being added may need additional anchor bolts at cripple wall sheathing locations	Anchor bolts connecting wood sill to foundation	No anchorage	<b>HIGH</b>	Add new anchor bolts or retrofit anchors attaching wood framing to foundation	X	X	X

Top priority for seismic rehabilitation if HIGH or MEDIUM. This is one of the most commonly seen failure types, occurring in most moderate to major earthquakes since the late 1800's. Benefits of seismic rehabilitation are much greater than cost. A condition survey is required for decayed wood framing, rusted anchor bolts, deteriorated foundation, no continuous foundation <b>Resources:</b> IEBC Appendix Chapter A3, local building department guidance, FEMA G225, ATC 50-1 Chapter 5, FEMA 547 Chapter 5, Standard Plan A Residential Seismic Strengthening Plan and Home Earthquake Retrofit Series.

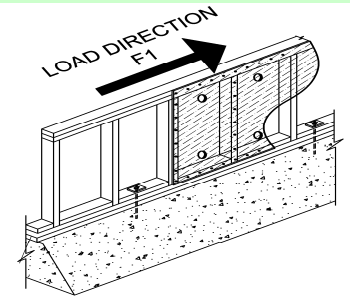
Install sheathing on cripple wall to resist load direction F1 (usually installed on inside face of cripple wall, but exterior also OK)	Top priority for seismic rehabilitation. This is one of the most commonly seen failure types, occurring in most moderate to major earthquakes since the late 1800's. A condition survey is required for decayed wood framing, rusted anchor bolts, deteriorated foundation, no continuous foundation <b>Resources:</b> IEBC Appendix Chapter A3, local building department guidance, FEMA G225, ATC 50-1 Chapter 5, FEMA 547 Chapter 5, Standard Plan A Residential Seismic Strengthening Plan and Home Earthquake Retrofit Series.

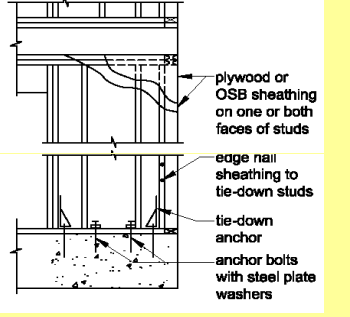
Well detailed narrow shear wall including: -OSB or plywood -anchor bolts -tie-downs	Shear walls may be too narrow to meet requirements of code. Where this occurs, design by an architect or engineer is needed. Tie-downs need to go into continuous footing that is of adequate size and strength; this sometimes means adding a footing. Design by an architect or engineer is needed. Post-tensioned slabs require architect or engineer guidance when adding anchorage <b>Resources:</b> ATC 50-1 Section 8.5, FEMA 232 Chapter 9, FEMA 547 Chapter 5

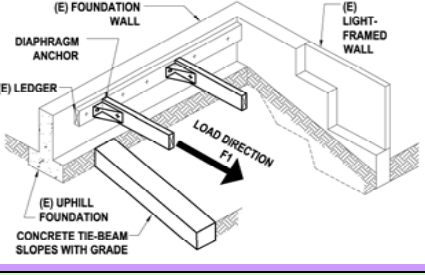
Provide adequate capacity at uphill foundation/ stiffest load path	Should be top priority for seismic rehabilitation. Damage of this type was seen in the 1994 Northridge Earthquake. <b>Resources:</b> City of Los Angeles Building Code, ATC 50-1 Section 8.6, FEMA 547 Chapter 5

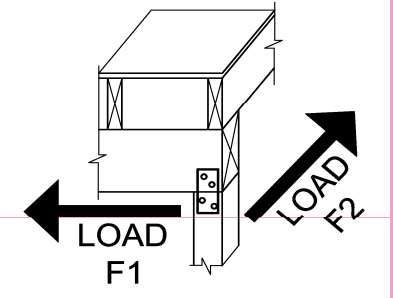
Fasten post to framing above and below to resist forces F1 and F2	Corrosion resistant hardware and fasteners should be used where exposed to weather or to pressure treated framing members. Connection should not be so stiff that it resists post rocking. <b>Resources:</b> ATC 50-1 Section 6.6.

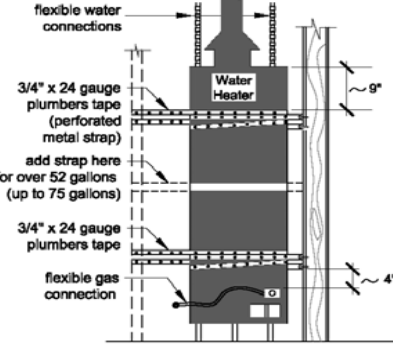
Strap or brace water heater	Should be top priority for seismic rehabilitation. Water heater failure occurs very commonly in moderate to large earthquakes. Significant fires have sometimes occurred due to gas line rupture. Strap or brace water heater to wall, secure base or pedestal to floor, provide flexible gas and water lines to water heater to avoid rupture. <b>Resources:</b> ATC 50-1 Chapter 6, FEMA 232 Chapter 8, California Division of the State Architect Waterheater Guidelines
